Contract #: 04-0120F4Cty: SF/ALA Rte: 80 PM: 13.2/13.9File #: 1.28**WELDING INSPECTION REPORT****Resident Engineer:** Casey, William**Address:** 333 Burma Road**City:** Oakland, CA 94607**Report No:** WIR-028152**Date Inspected:** 10-Aug-2012**Project Name:** SAS Superstructure**OSM Arrival Time:** 700**Prime Contractor:** American Bridge/Fluor Enterprises, a JV**OSM Departure Time:** 1930**Contractor:** American Bridge/Fluor Enterprises, a JV**Location:** jobsite**CWI Name:** See Body of Report**CWI Present:** Yes No**Inspected CWI report:** Yes No N/A**Rod Oven in Use:** Yes No N/A**Electrode to specification:** Yes No N/A**Weld Procedures Followed:** Yes No N/A**Qualified Welders:** Yes No N/A**Verified Joint Fit-up:** Yes No N/A**Approved Drawings:** Yes No N/A**Approved WPS:** Yes No N/A**Delayed / Cancelled:** Yes No N/A**Bridge No:** 34-0006**Component:** OBG**Summary of Items Observed:**

Quality Assurance inspector (QA) Matthew Daggett was at the American Bridge/Flour (ABF) job site at the San Francisco/Oakland Bay Bridge in California between the times noted above in order to monitor Quality Control functions and the in process work being performed by ABF personnel. The f

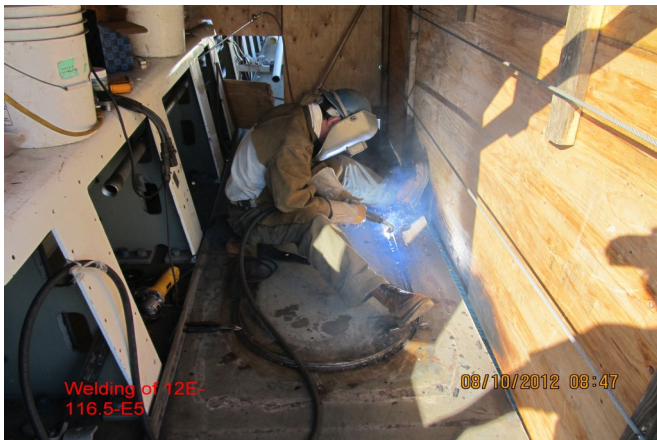
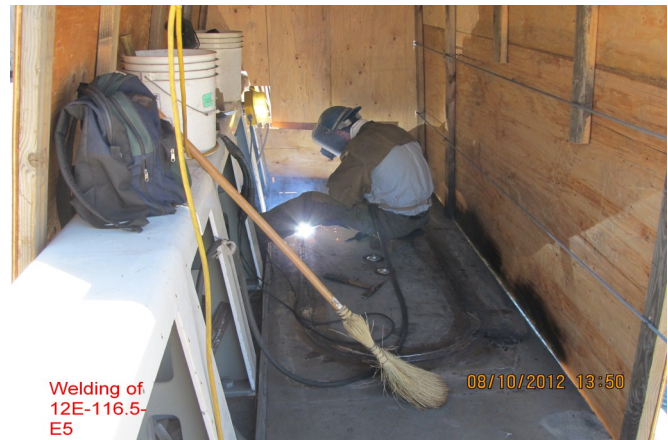
ABF welding personnel Jin Pai Wang (7299) on Deck access hole 12E-PP116.5-E5 circumference weld. The welder is in the process of placing the fill passes at this time with approximately 80% being completed at the end of the shift. QC inspector Fred Michels was noted to be present in order to monitor the progress and ensure the welding was within the established Welding Procedure Specification (WPS) noted as ABF-WPS-D15-3040-A1 and supporting Procedure Qualification Records (PQR). Prior to initiating the welding at this location the QC inspector observed the preheat temperature using a Raytek non-contact Thermometer was sufficient and compliant to the above-mentioned WPS. Using a Tempil Stick (temperature indicating crayon) the preheat and interpass temperature was then verified by this QA inspector to be greater than 150F and the parameters using a Fluke brand Tong style meter was verified to be 265 amps, 23.3 volts. The work progressed throughout the shift and appeared to be in general conformance with the contract documents. See digital photo included in the body of this report for general information.

The QA inspector noted and periodically observed ABF welder Roby Smith (4245) performing the back gouging and grinding operations on Side B of Deck Access Hole 12W-W116.5-W5 . QC inspector Chris Concha was noted to be in the vicinity in order to monitor the progression of work, perform in process visual inspection and ensure the work was being performed in general conformance with the contract documents. The work was not completed on this date and appeared to be progressing in general conformance with the contract documents.
